U.S. DEPARTMENT OF
ENERGY

EM Crews Think Outside the Box for Hanford Tank Waste

June 25, 2019

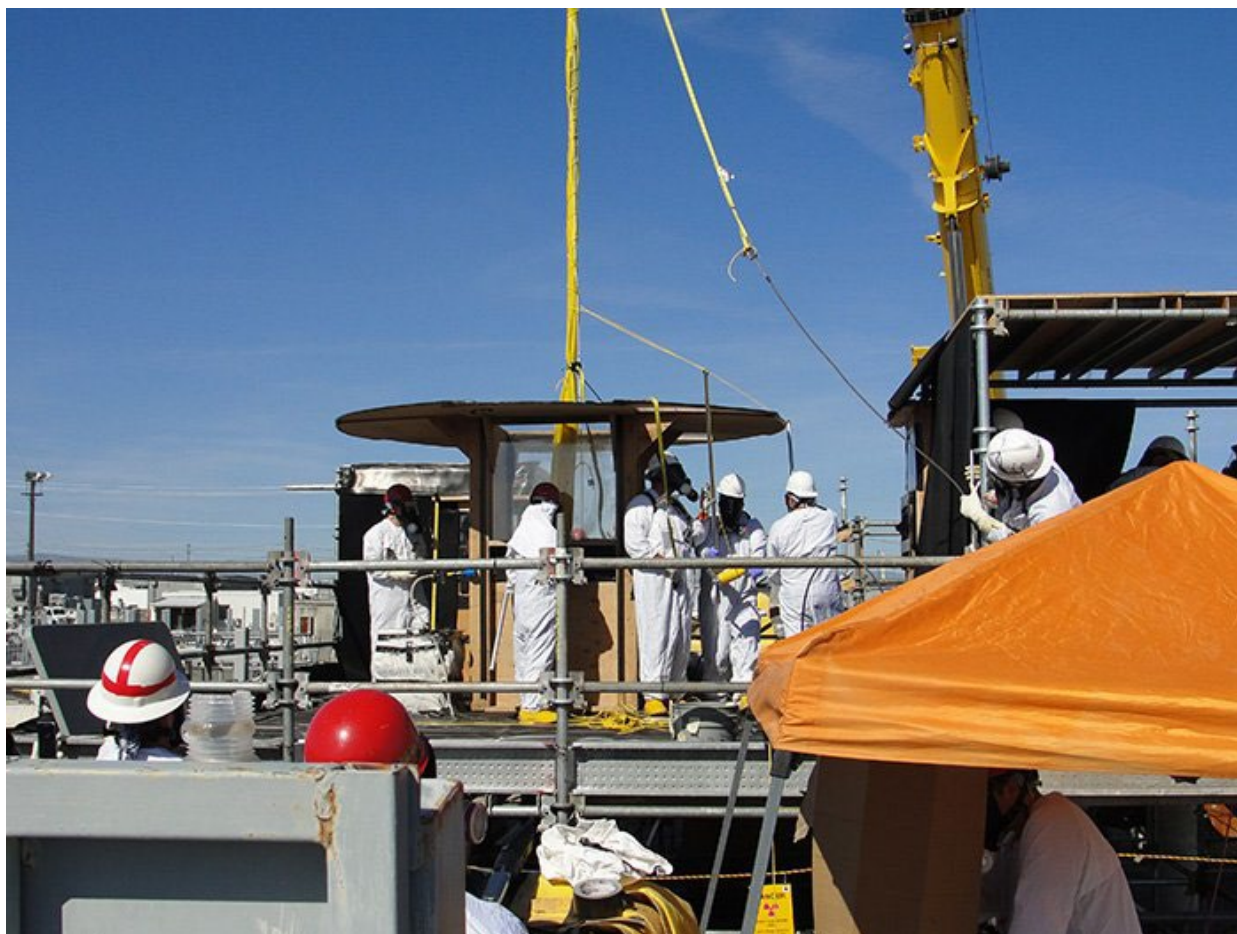
A Hanford Site team created unique tools to remove a radiologically contaminated thermocouple from single-shell tank AX-103. The team built a radiation-shielding box and remote extension tools to allow workers to complete the task more safely.

Extensive planning and innovation led to the removal of the 54-foot-long thermocouple from tank AX-103 in two sections. This allowed crane operators to control the long, thin device, which needed to be rotated from the vertical to horizontal position for placement into a shielded disposal box.

Workers removed the 7-foot-long top section of the thermocouple according to plan, but the 47- foot-long lower section took longer to remove safely. As workers raised the thermocouple from the tank, radiological surveys indicated higher dose rates where workers were planning to attach the crane rigging. The project team reevaluated the situation and set up additional safeguards.

The team improved the shielded box design so that workers were further away and could use remote reach tools to attach rigging. The team also built a shielded cover that allowed workers to secure the sleeving, all of which made the third attempt successful. The thermocouple is encased in plastic sleeving to prevent the spread of contamination.
